# Manhole Inspection Summary

Manhole # S45G2\_029MH

Insp Date: **1/10/08 10:07 AM**

**Location** Address: **1524 Locust-Hazel**

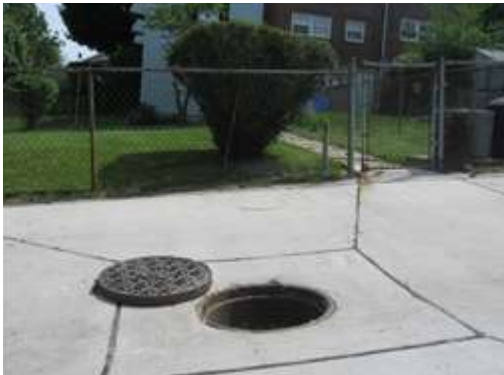
Location View

1524 Locust-Hazel

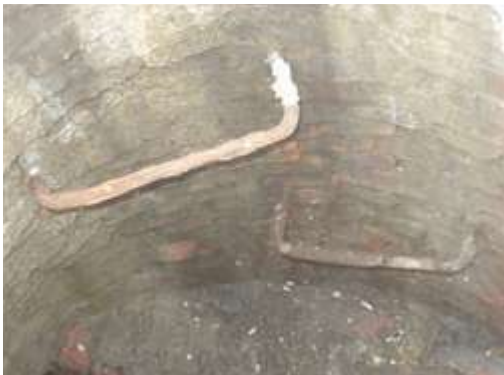
Steps

**Steps** Count: **2** Missing: **0** ☐ Corroded

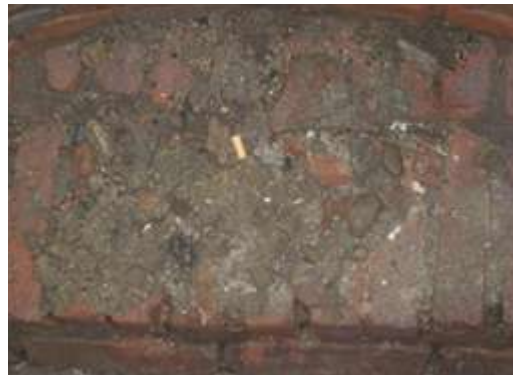
Defect 2

Debris on bench

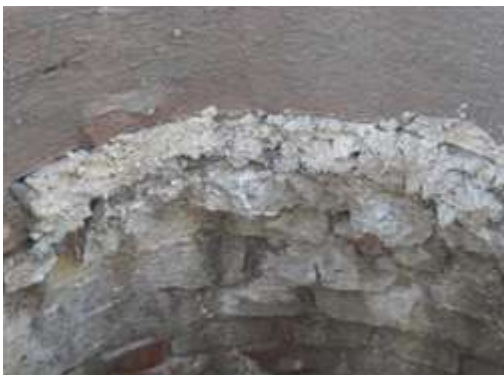
Defect 1

Infiltration: ☐ None ☐ Joint ☐ Cracks ☒ Mortar ☐ Roots ☐ Wall

Mortar infiltration

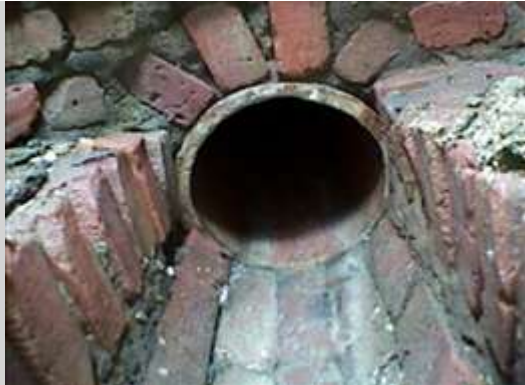
12 O'Clock Outflow

8 in. Circular Gravity Sewer  
Pipe Out @ 12 O'Clock

Pipe Height: **8.4** (in.) Rod and Bar (Angled)  
Pipe Material: **Clay** ☐ Pipe Lined  
Invert Depth: **6.20** (ft.) Flow Characteristics: **Fast**  
Deposits: ☒ None ☐ Mud ☐ Sludge ☐ Debris ☐ Grease  
Silt Depth: (in.) Deposits Extent:  
Infiltration: **None** Pipe Seal Cond: **Sound**

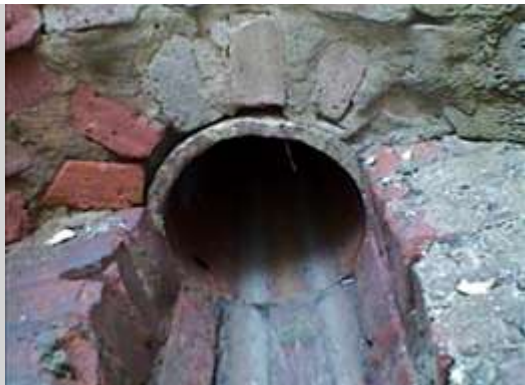
6 O'Clock Inflow

8 in. Circular Gravity Sewer  
Pipe In @ 6 O'Clock

Pipe Height: **8.4** (in.) Rod and Bar (Angled)  
Pipe Material: **Clay** ☐ Pipe Lined  
Invert Depth: **5.83** (ft.) Flow Characteristics: **Fast**  
Deposits: ☒ None ☐ Mud ☐ Sludge ☐ Debris ☐ Grease  
Silt Depth: (in.) Deposits Extent:  
Infiltration: **None** Pipe Seal Cond: **Sound**
